**INSTALLATION INSTRUCTIONS:  
Stage 3 Radius Arms, 1966-77 Bronco**

**PART #5350**

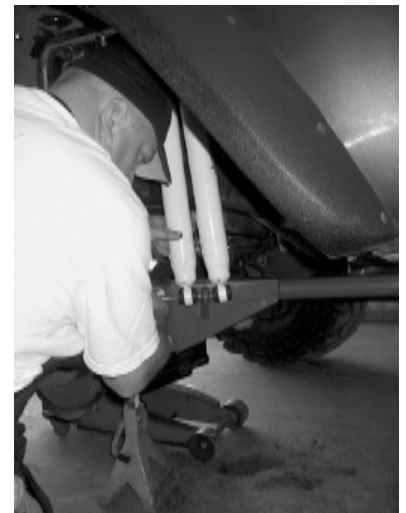
24. Reinstall the front tires and wheels.

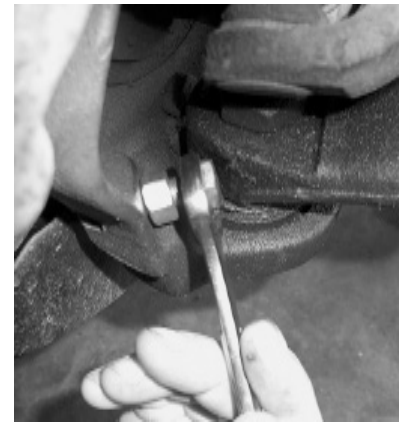
25. Due to variations in tire size and wheel offset, check clearances around shocks, shock mounts and radius arms. Also check that the front axle u-joint is not binding at full steering lock. Adjust the steering stops located on the backside of each knuckle to correct any interference. We highly recommend that an alignment be performed on the vehicle as soon as possible. After the alignment has been performed turn the steering wheel lock to lock to verify the steering stops are properly adjusted. Failure to do so could result in damage to tires, wheels or shocks.

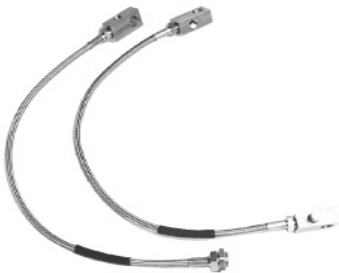
## Stainless Steel Braided Brake Hoses

Lifted Broncos with lots of travel need longer brake lines to get the most from the suspension. These custom lines are stainless steel and DOT approved for street legality as well as being longer to accommodate suspension travel. These lines won't swell under pressure like rubber ones will. Smaller inside diameter increases pedal feel and brake response. Beware many replacement lines are not DOT approved! We have these specially made so you don't have to guess when it comes to the safety and soundness of your brakes. Fits stock to 6" lifted 66\*-77 Broncos. Note: \*66 & 67 may need adapted to fit front hose. **#3931 Stainless Braided Hoses, 66-77, pair**

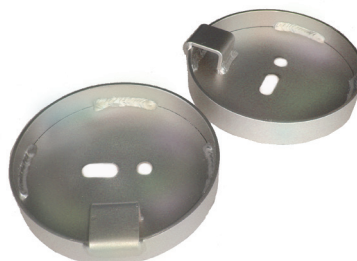
**#5120 Lower Coil Spring Retainers \$75/pr.**

You may notice that your coil springs "bow" after installation. This is the nature of a modern soft progressive rate coil spring. The amount of bow depends on the vehicle. If the problem is excessive in your vehicle, you can replace the lowers with our new lower retainers which will significantly reduce, if not eliminate the problem.
